Preliminary Maintenance Inspection

40,000 Gallon
Double Ellipse

Lake County DPW
Countryside Manor Tower
#4811110

Libertyville, Illinois

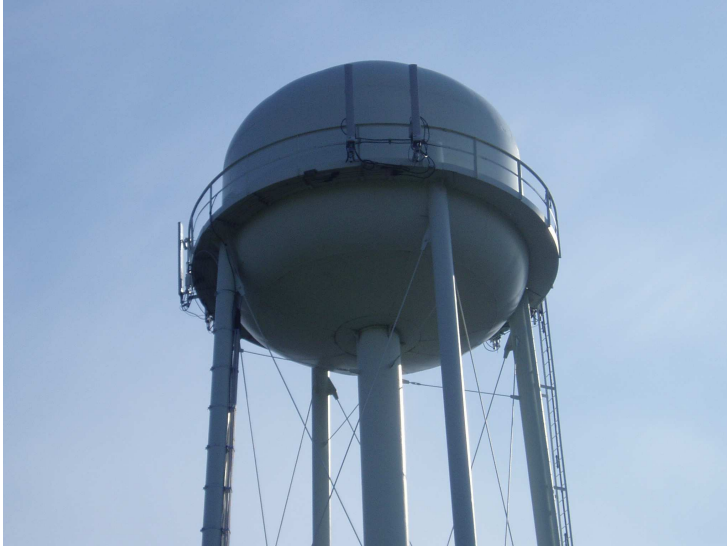
1) View of the exterior bowl and sidewall.

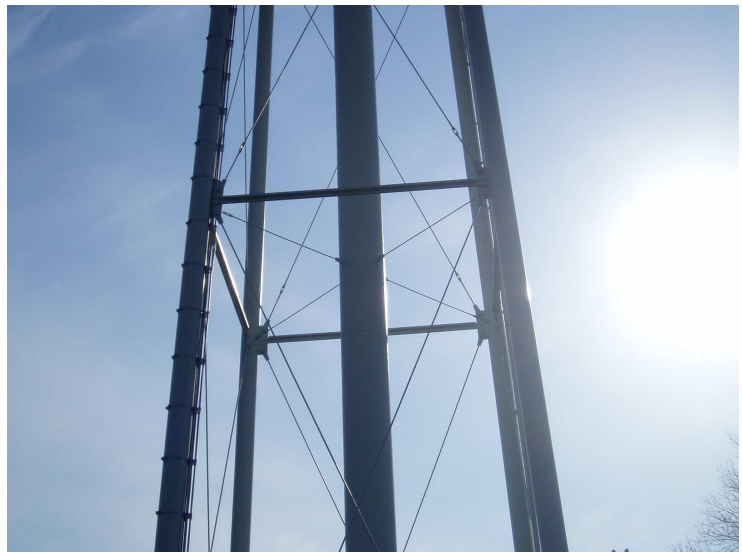
2) Looking at the exterior legs and riser.

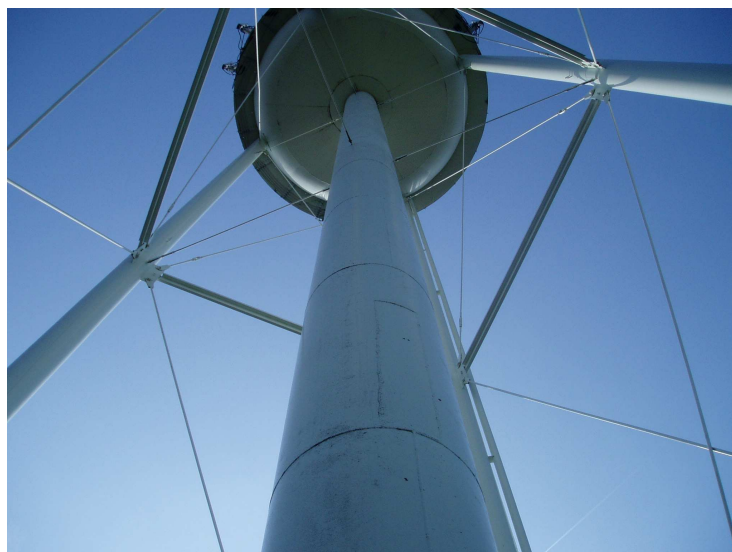
3) View of the bowl and riser.

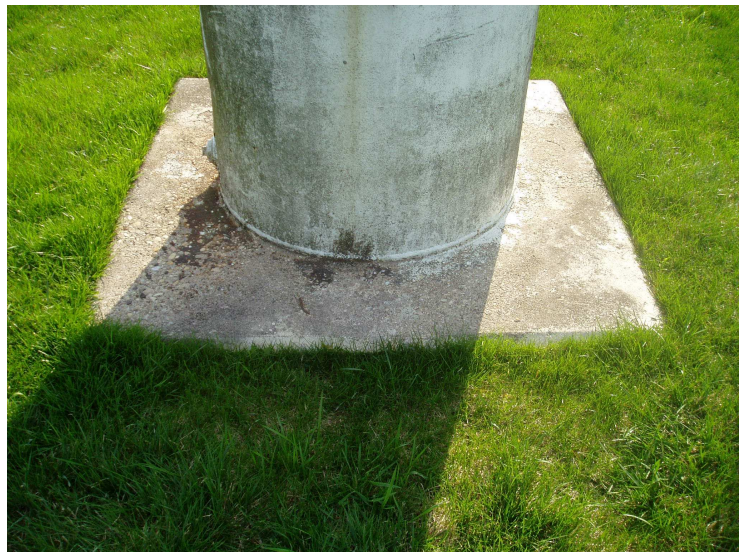
5) Mildew growth on the bottom of the exterior riser.

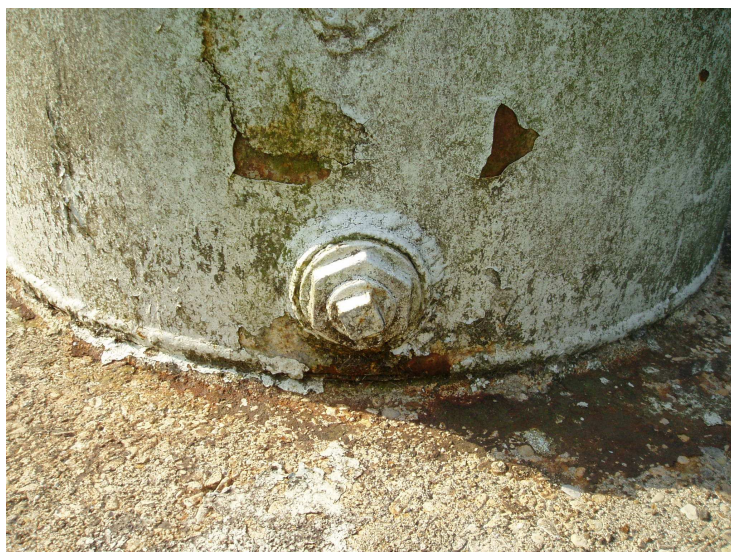
The riser coating is in fair condition. There are minor coating breaks with small amounts of surface rust and rust staining. Primary methods of deterioration are spot coating breaks and delamination. There are minor coating breaks with small amounts of surface rust and rust staining on the riser.

6) Coating delamination on the bottom of the exterior riser.

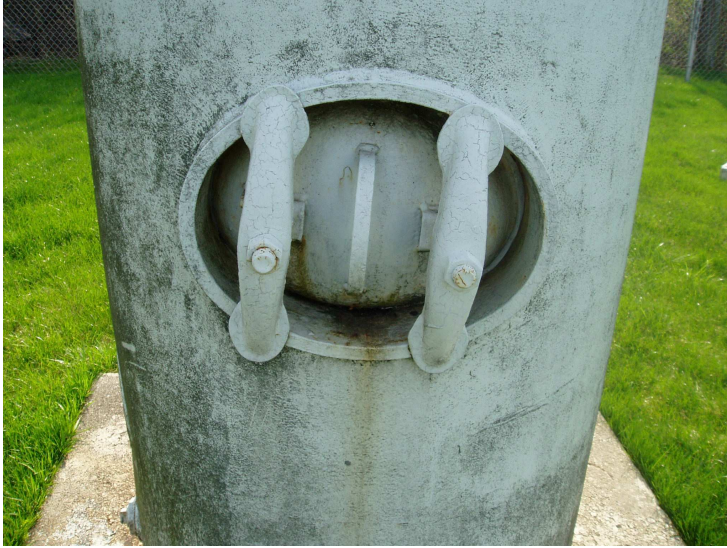
The tank has a 12 x16-inch elliptical access manway in the riser that is in good condition.

7) Bolted manway at the bottom of the riser.

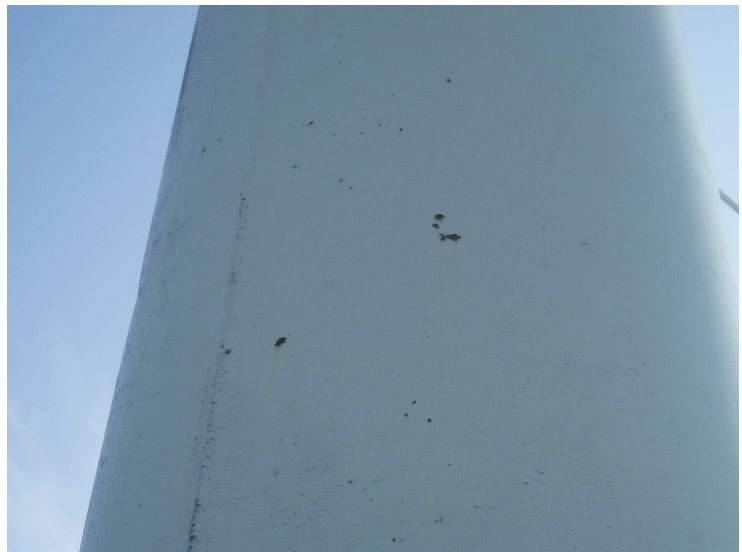
8) Spot coating failures on the exterior riser.

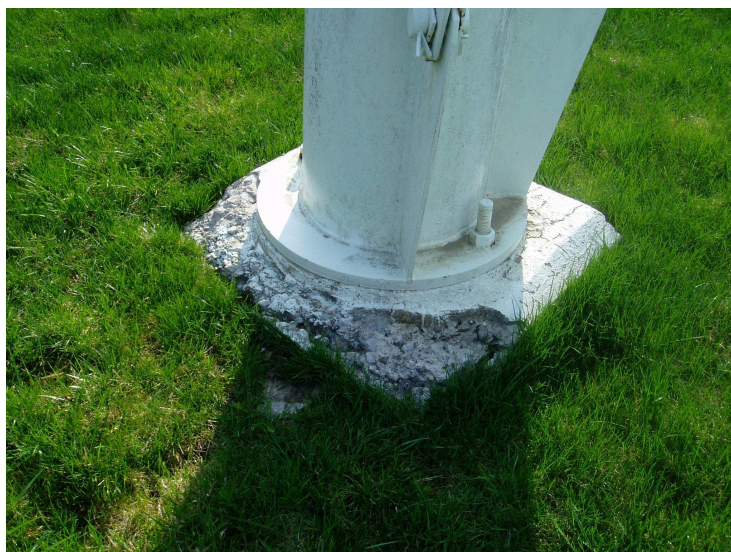
One leg foundation is in poor condition. The concrete is spalled without rebar exposure. Some cracks may be deep enough to present a structural problem.

Leg comments: The northeast leg foundation is badly deteriorated with large cracks and chipping. The other 3 legs have a good foundation.

9) Foundation for an exterior leg is in poor condition.

Rebuild the leg foundation using an epoxy grout. This will require removal of all loose and mottled concrete and attachment of tieback into the existing concrete. This work should be completed without loading from the tank proper. A temporary foundation to assume the dead load of the tank may be required. The estimated cost is \$4,000.

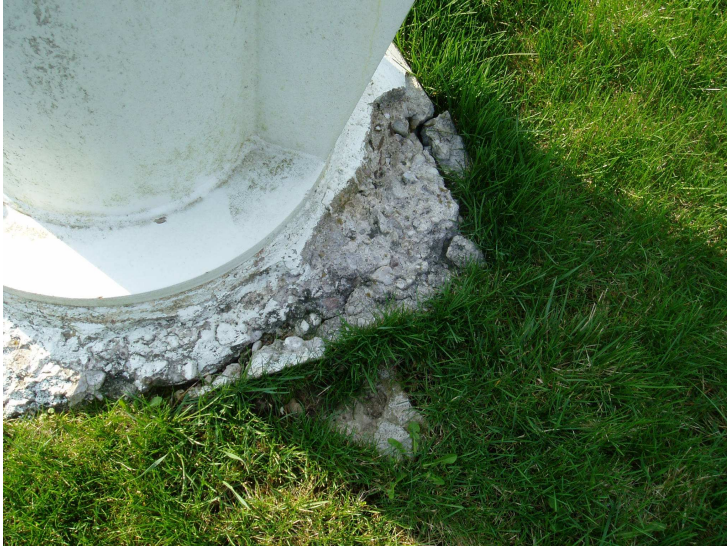
10) Leg foundation is has large areas of spalling concrete.

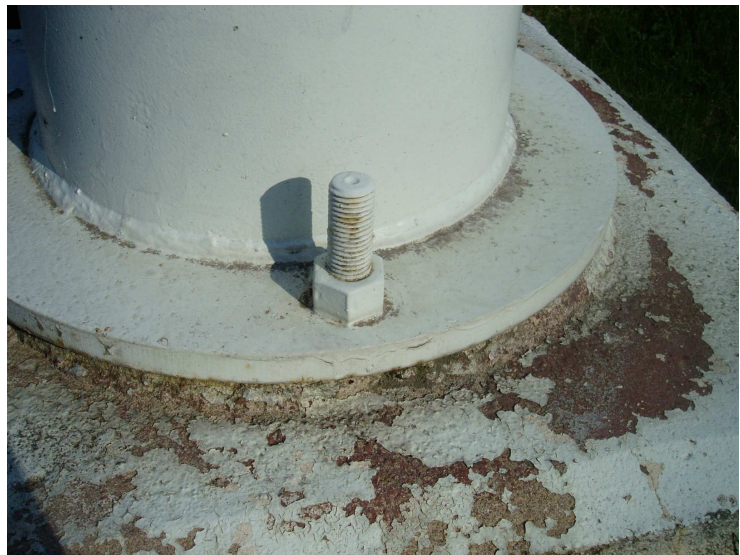
The grout is in fair condition. 1 foot of the grout is missing between the bottom plate and the leg and riser foundation.

11) Area of missing grout between leg base plate and foundation.

Remove all loose or deteriorated leg and riser grout then repair with an epoxy grout. The estimated cost is \$1,000.

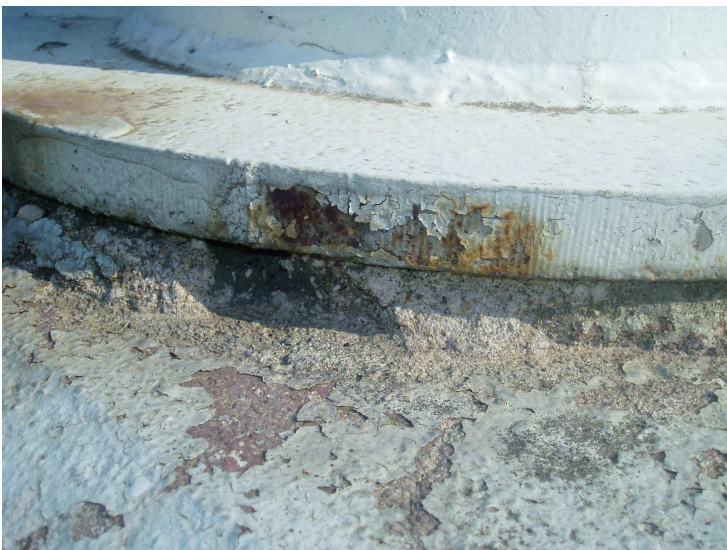
12) Closer view of the missing grout.

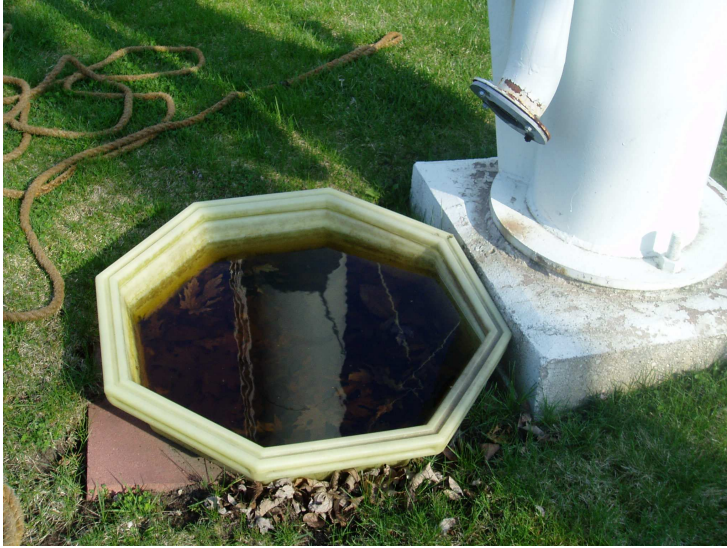
13) Overflow pipe with discharge area.

Install a screened flap gate with a corrosion resistant screen on the end of the overflow pipe. The flap gate would allow water to discharge even if the screen becomes plugged or frosted over. It is designed to stay closed to prevent rodents or birds from entering the pipe. The estimated cost is \$1,000.

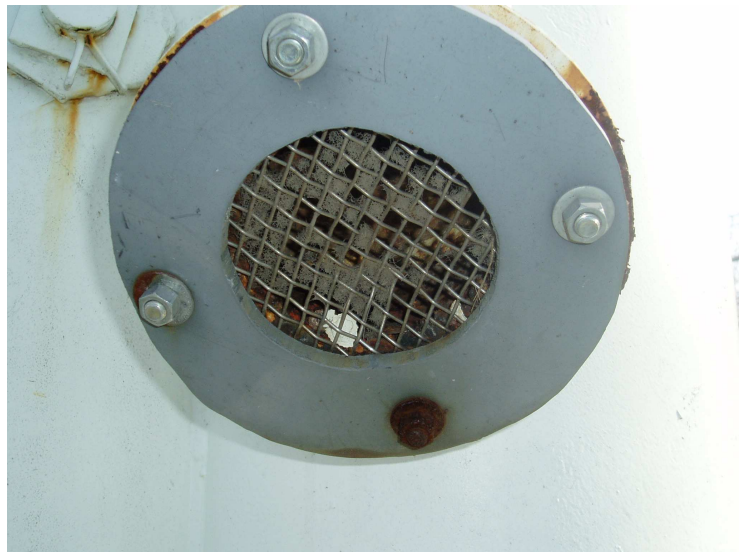
The discharge end of the overflow pipe is screened. The screen is in fair condition.

14) Looking at the screen on the overflow.

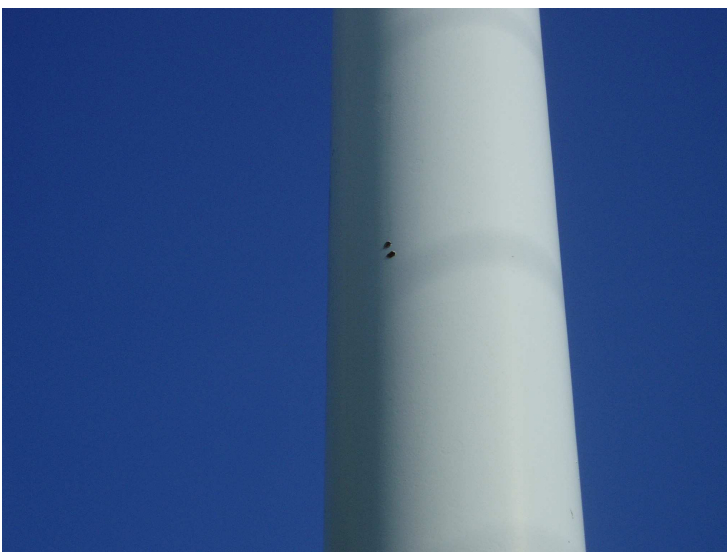
Several areas of rock chip damage were noted on the lower legs. These areas have started to surface rust and undercut the surrounding coating. The coating is 9 - 16mils thick on the legs.

15) Looking at a spot coating failure on a exterior leg.

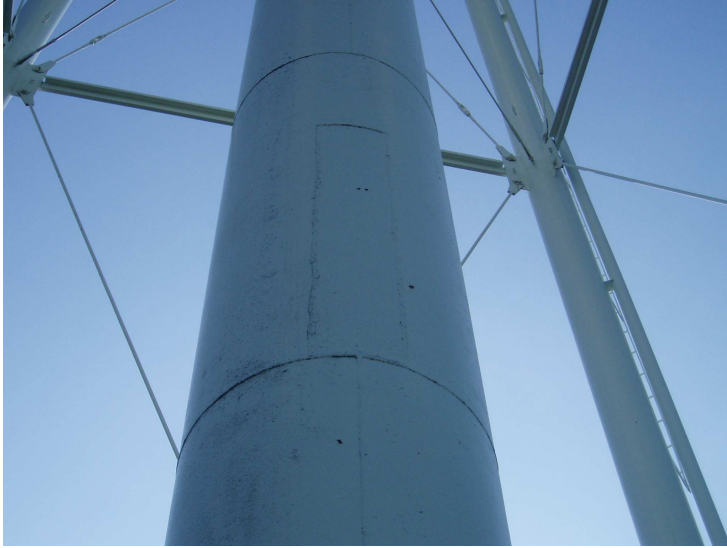
16) Another view of the exterior riser with spot failures.

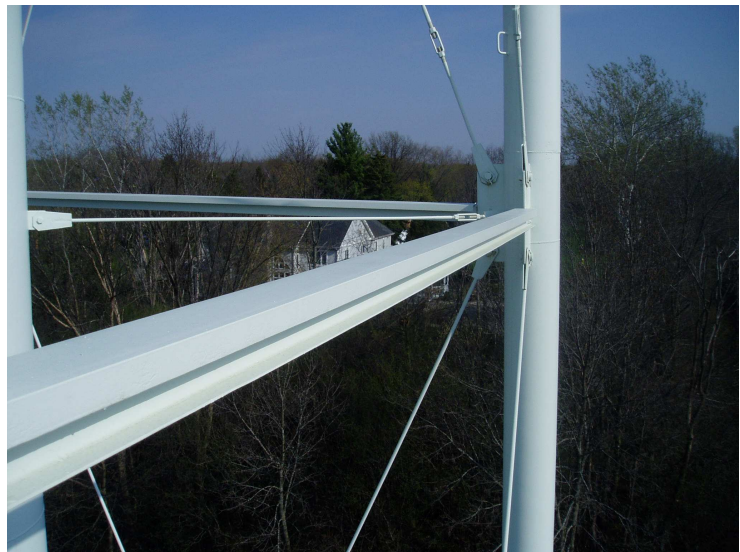
The coating on the sway rods is in fair condition with minor spots of coating failure and surface rust on the rods and turnbuckles, and on the struts between the leg columns.

17) Looking at the struts and sway rod connection to the leg.

Adjust the sway rods. Loose sway rods will allow the tank to move excessively placing undue stress on the connections. The estimated cost is incidental to the exterior painting.

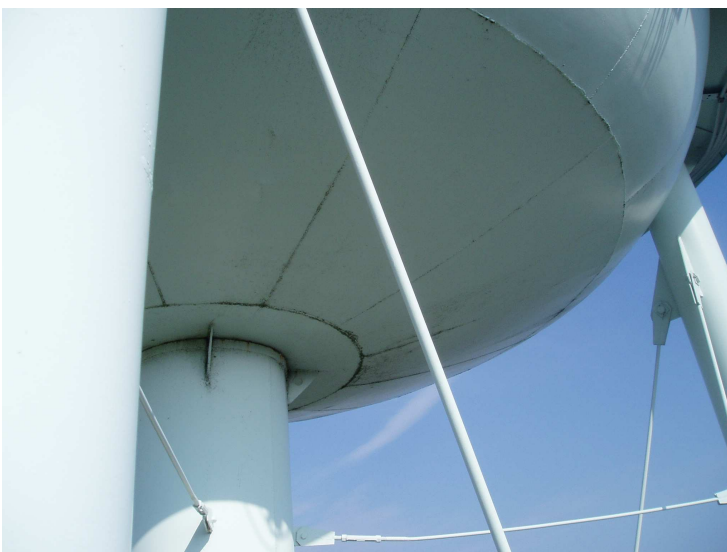
18) Coating on the exterior bowl is in good condition.

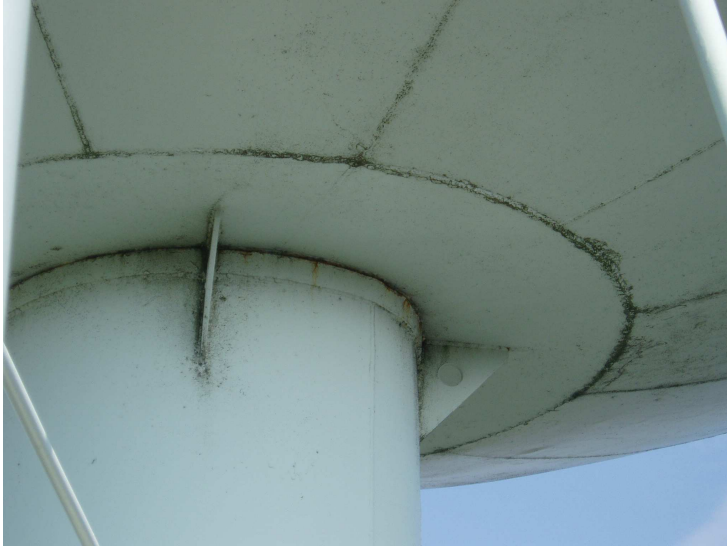
19)Riser connection to the bowl is in good condition.

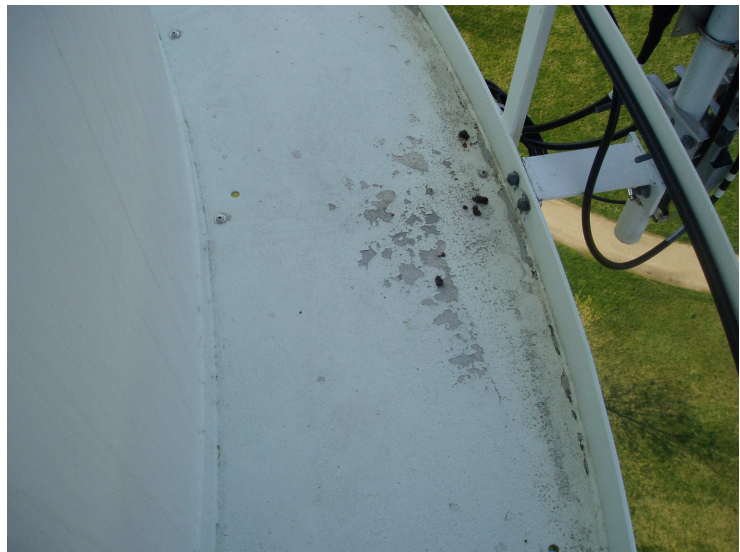
20)Spot coating delamination on the balcony floor.

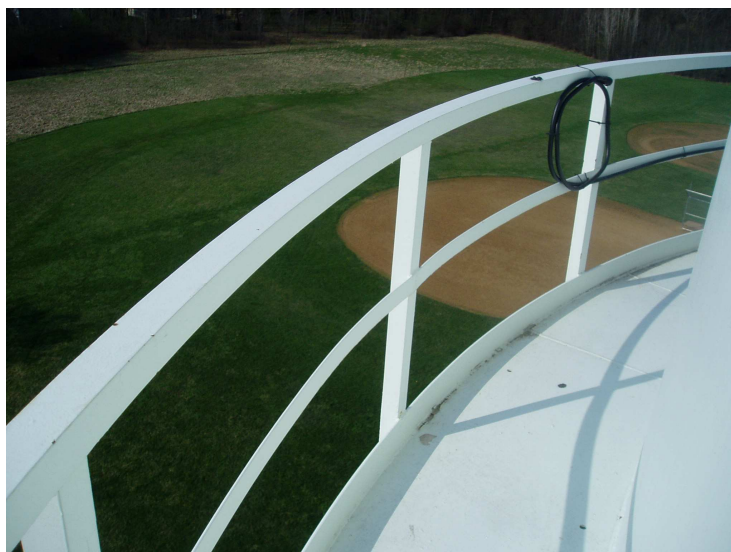
The exterior balcony is in good condition. The balcony on the exterior sidewall is 24-inches wide with a 36-inch high handrail. The handrail has a mid-rail and a kick plate at the balcony floor. The balcony and railing do not conform to OSHA requirements.

21)View of the balcony handrail.

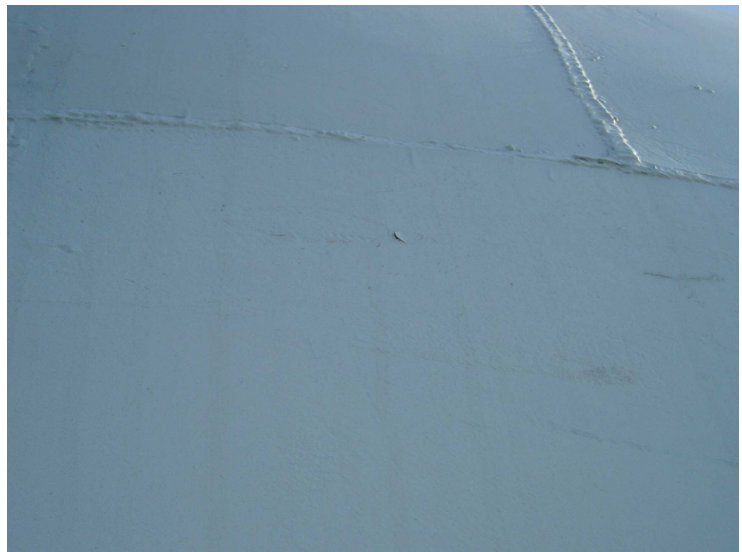
The exterior sidewall coating is in fair condition. Primary methods of sidewall coating deterioration are delamination, checking, and spot coating breaks to the substrate. There are minor coating breaks with small amounts of surface rust and rust staining. There are minor areas of rust bleed-through on the sidewalls.

23)Spot coating failures in the exterior sidewall coating.

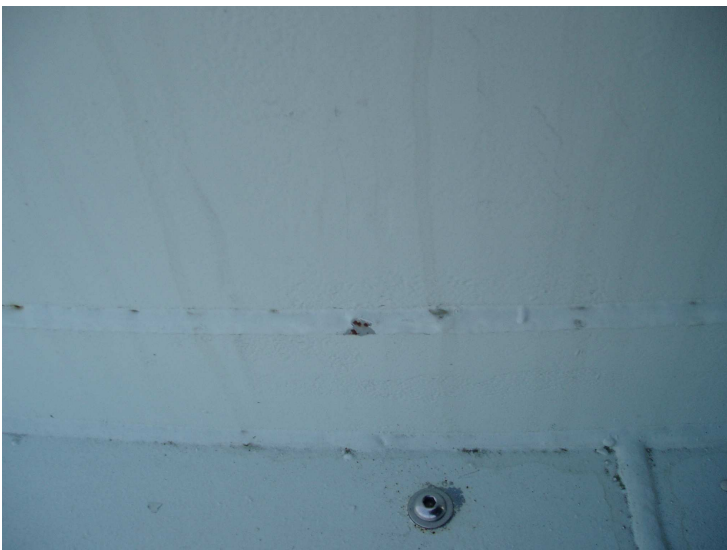
24)Coating delamination on the lower exterior sidewall.

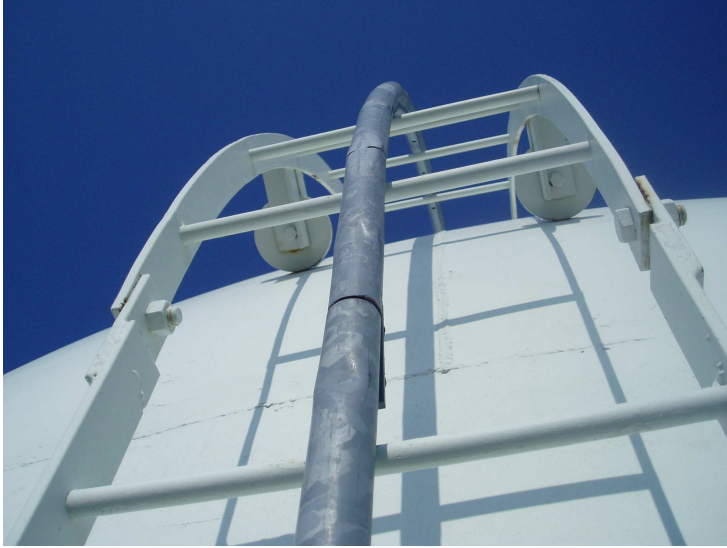
The tank has a revolving sidewall and roof ladder that is in good condition. The ladder does have a rail-type fall prevention device, preventing movement.

24) Revolving roof ladder with rail fall prevention.

The revolving roof and revolving sidewall shell ladder should be replaced with a vertical sidewall ladder that runs up to a step-off platform surrounded with handrails at the roof hatch. The step-off platform will provide a safe working area around the roof hatch. Estimated cost is \$5,000.

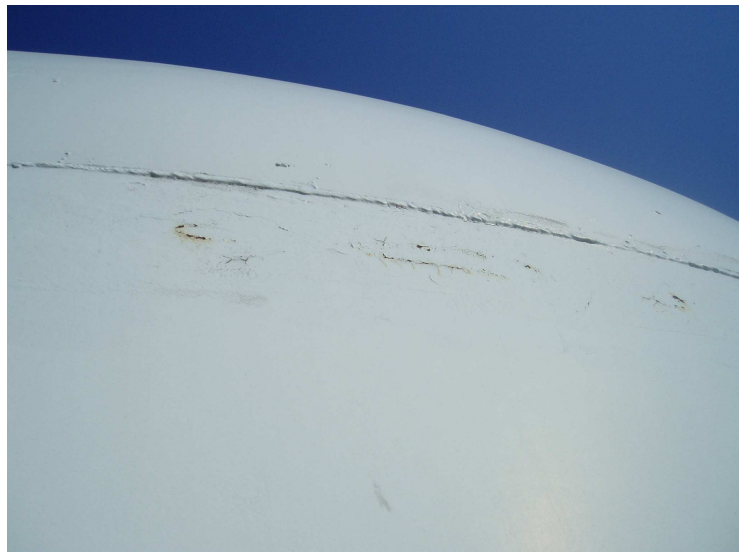
25) Coating damage to roof coating from ladder wheels.

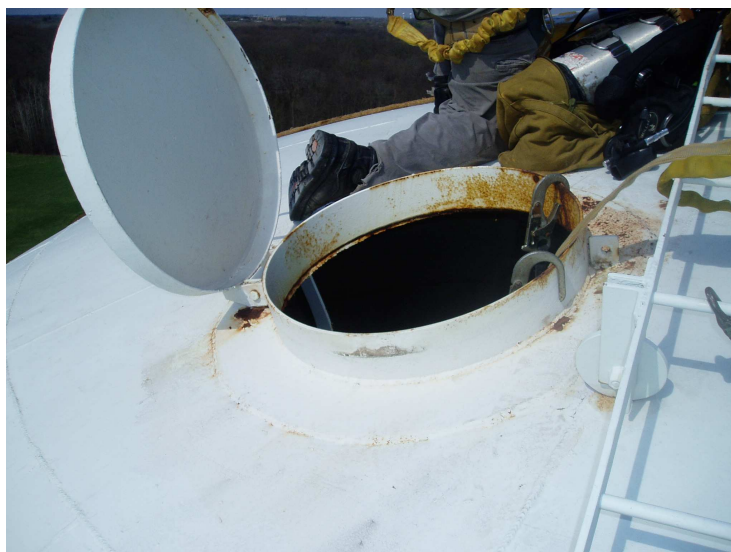
The tank has a 24-inch diameter flip-top, round roof access hatch to the wet interior. The hatch has a rainproof cover consisting of a 4-inch curb and a 2-inch lip on the cover. The hatch is in good condition.

26) Roof hatch to the wet interior.

Replace the roof access hatch with a new 30-inch curbed hatch that has a 2-inch lip, a 4-inch curb, and lockable hasp. Average rescue baskets and rescue personnel wearing equipment will not pass through the existing 24-inch hatch. The estimated cost is \$3,000.

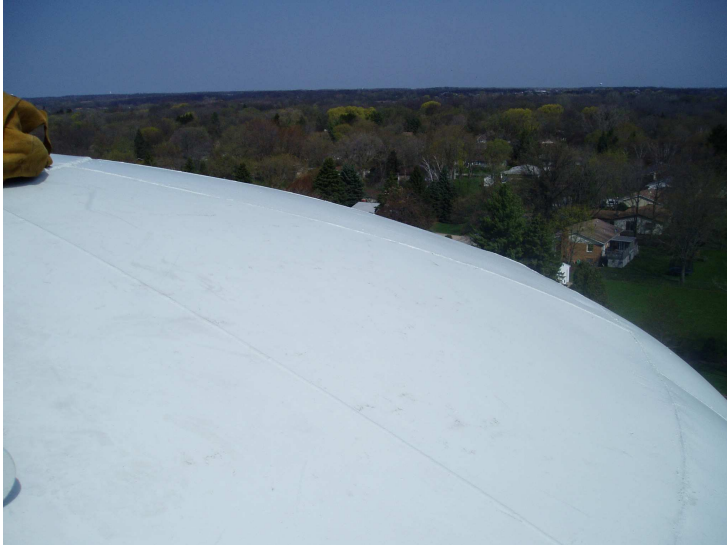
The exterior roof coating is in fair condition. Primary methods of roof coating deterioration are delamination, checking, rust bleed-through, and spot coating breaks to the substrate. There are minor areas of rust bleed-through on the roof. There are minor coating breaks with small amounts of surface rust and rust staining on the roof.

27) View of the roof coating.

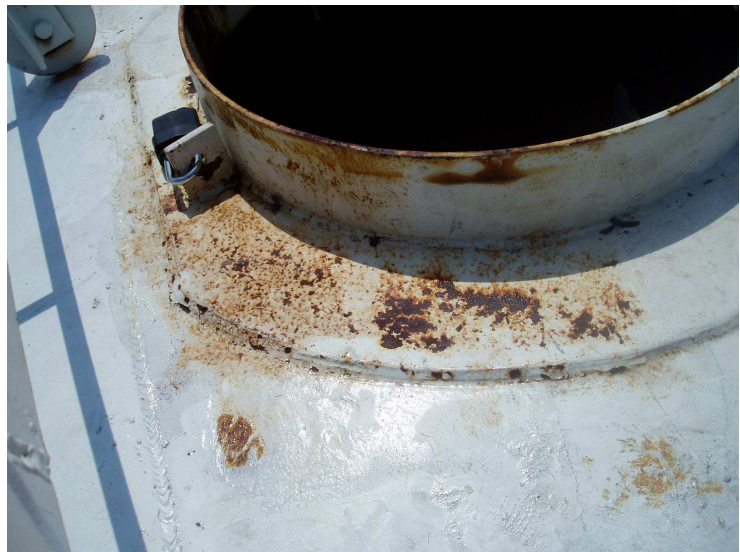
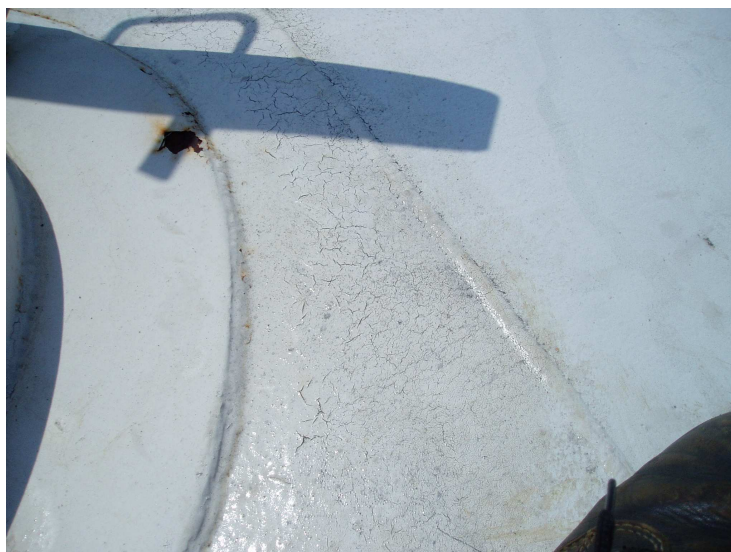
28) Coating around the roof hatch is in poor condition.

29) Same.

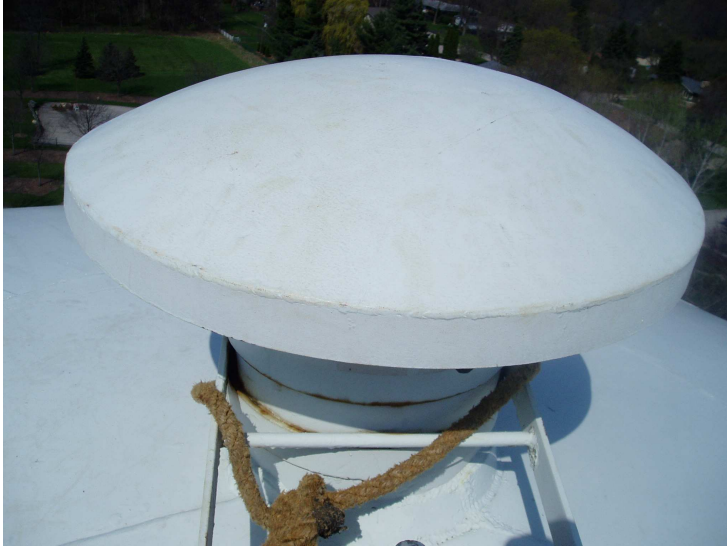
The roof vent is a 16-inch flow-through design. The vent is in good condition.

30) The roof vent is in good condition.

Replace the roof vent with a new, screened pressure vacuum vent. The new vent can be bolted to a new neck that is welded to the roof.

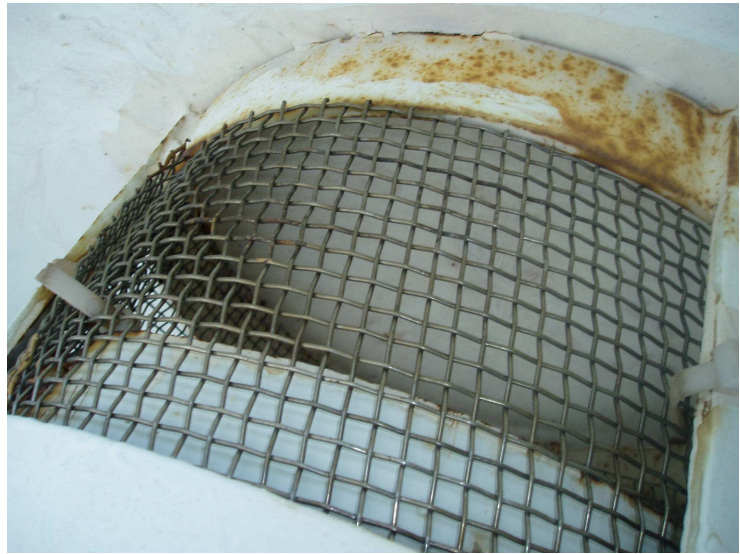
31) The screen on the roof vent is in good condition.

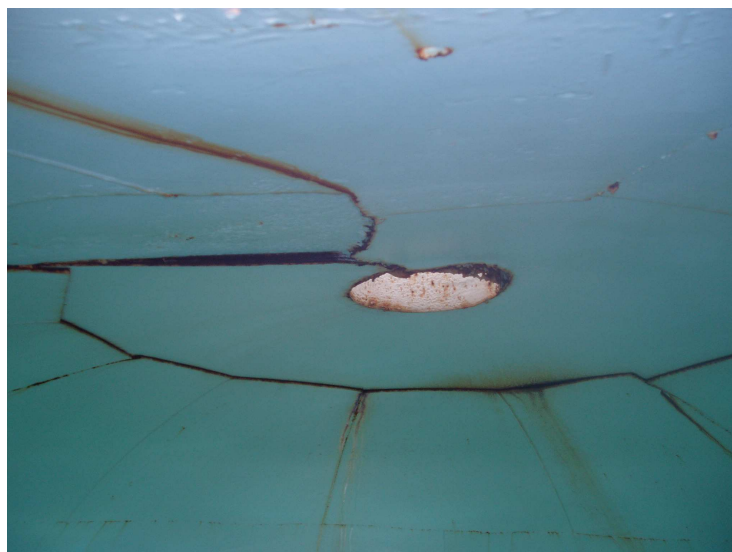
The roof coating is in fair condition. The coating is 99 percent intact, with the primary areas of deterioration along the lap seams, the beam edges, and in the crevices. The tank's roof contains open lap seams that have started to rust and streak. Staining is typical for a tank of this construction where the lap seams are open and not seal welded or caulked. Staining in the lap seams is not a concern, but should be monitored during future inspections for corrosion growth. Edge corrosion is typical but should be corrected before structural loss of steel occurs.

32) The wet interior roof coating is in fair condition.

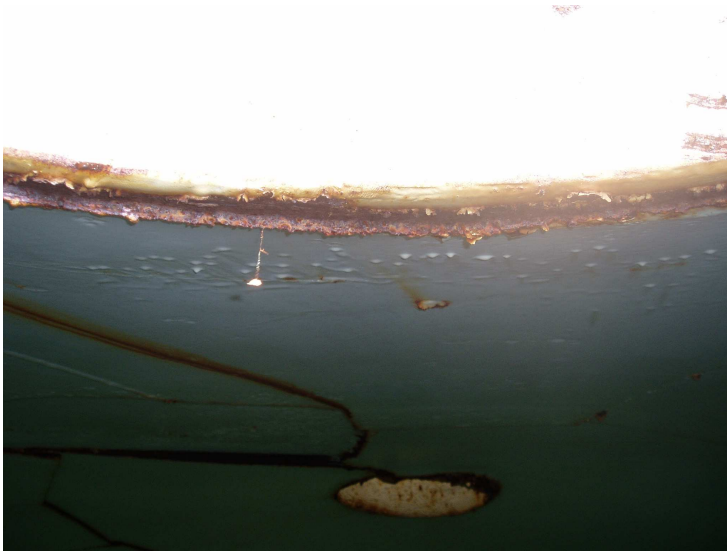
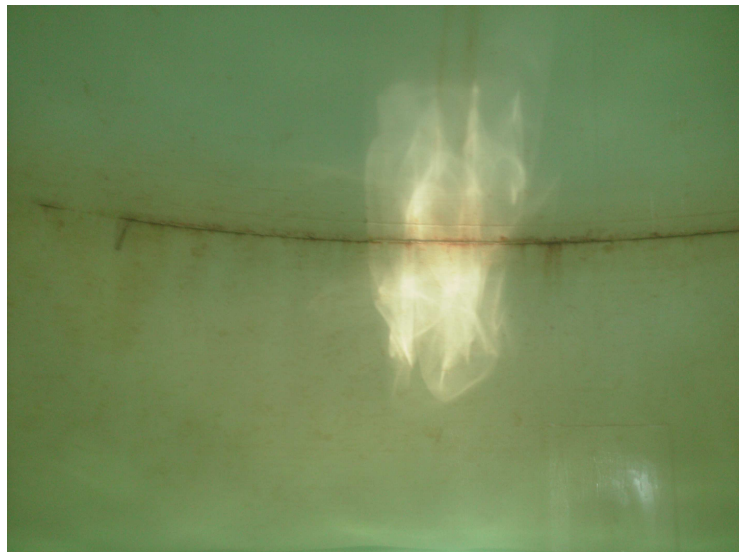
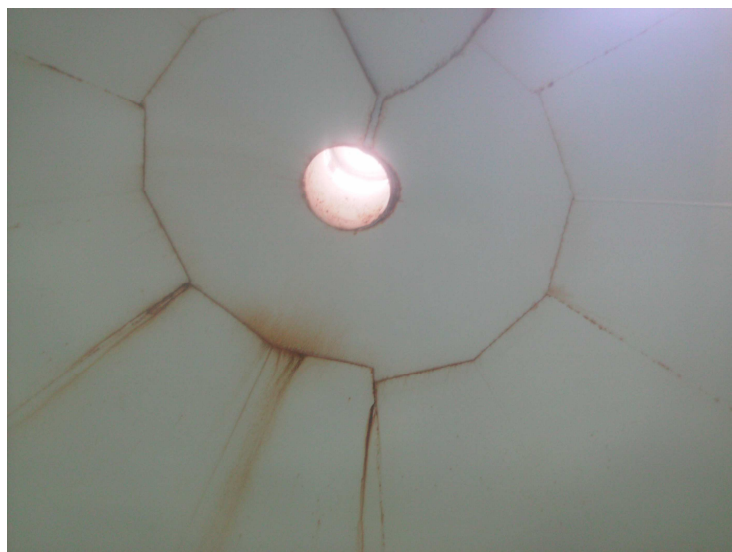
33) Rusting is occurring on the edges and in the crevices of the wet interior roof.

34) Same.

35) Same.

2. Abrasive blast clean the tank's entire wet interior to a near white metal condition (SSPC-SP10), and apply a three-coat epoxy polyamide system. The estimated cost is \$30,000.
3. After coating the wet interior, seam seal the roof lap joints with urethane caulk. The estimated cost is \$1,000.

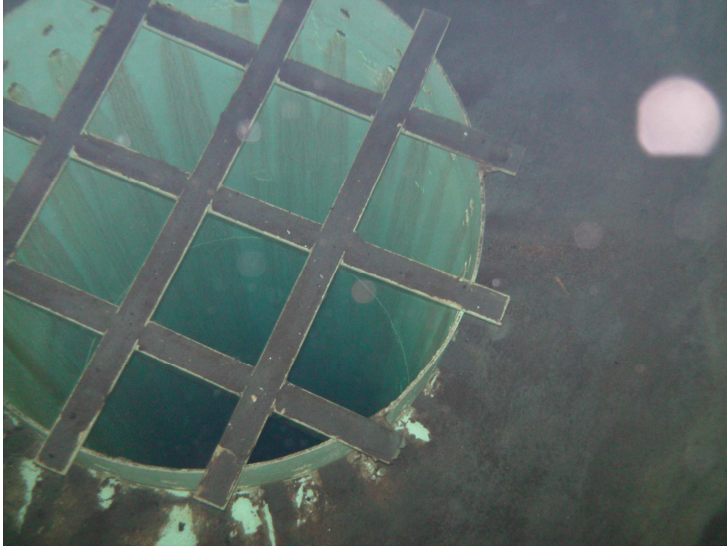
36) The floor is covered with a light layer of sediment. The riser grate is in good condition.

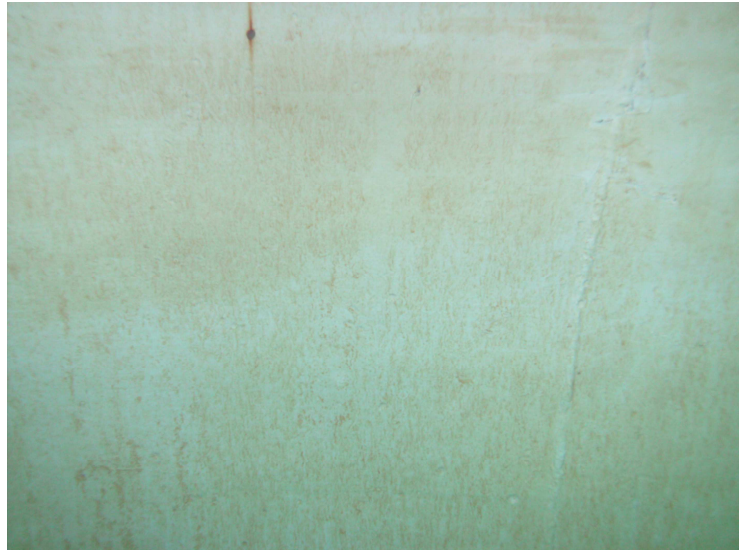
37) The coating on the roof knuckle is in good condition.

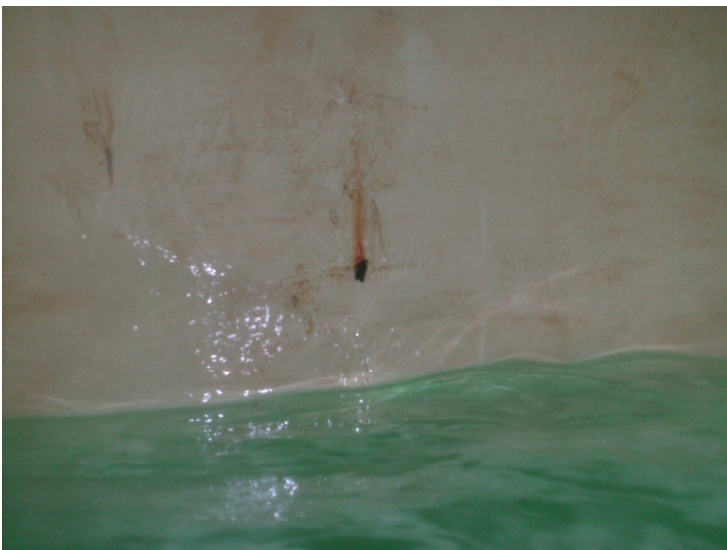
38) A few spot coating breaks were found on the sidewall above the high water level.

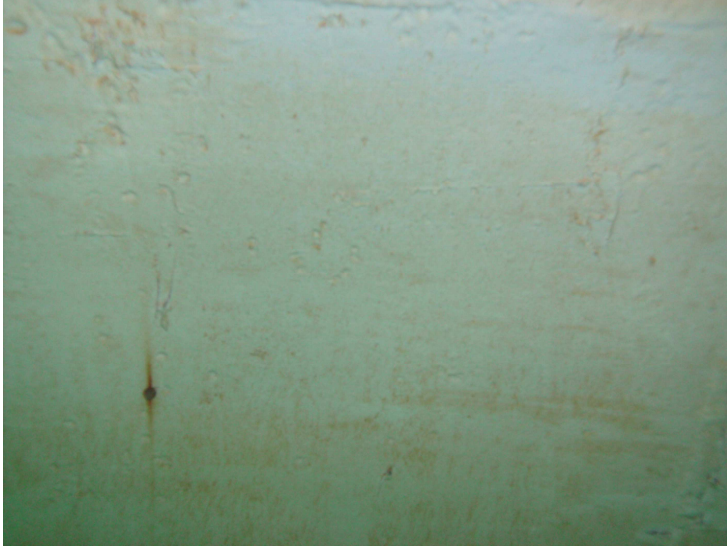
39) Spot coating breaks were found on the sidewalls below the water level.

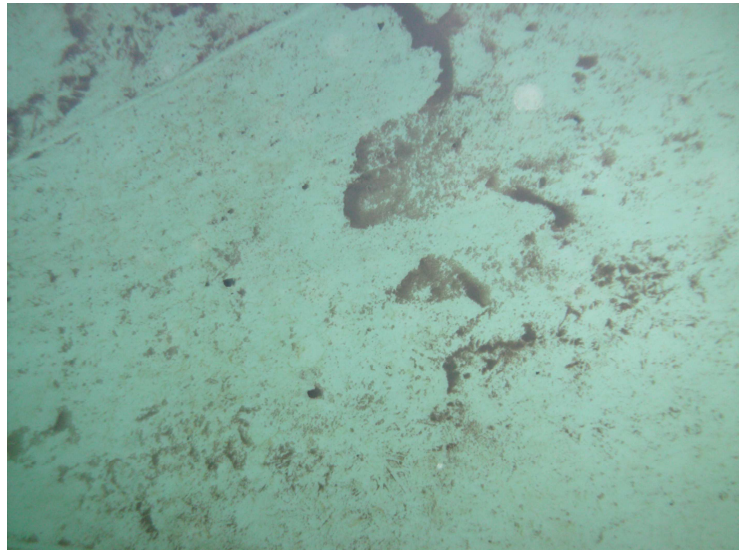
40) The coating on the lower sidewalls is in good condition.

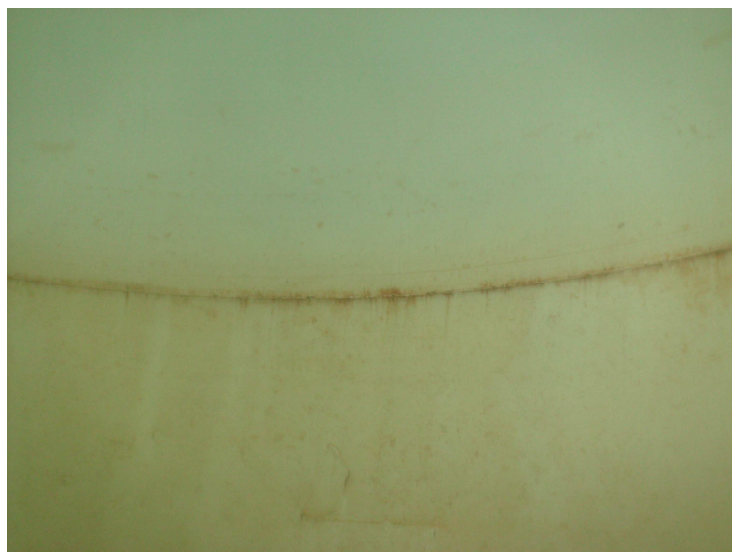
41) Coating on the sidewalls below the water level is in good condition.
